YAPILAR İnsanlar Gibidir BUILDINGS Are Like People

İBB GENÇLİK MECLİSİ MERKEZİ ÖNERİSİ RESTORASYON RAPORU

I. Yapı Kimlik Bilgileri

II. RESTORASYON ÇALIŞMASI AÇIKLAMA METNİ

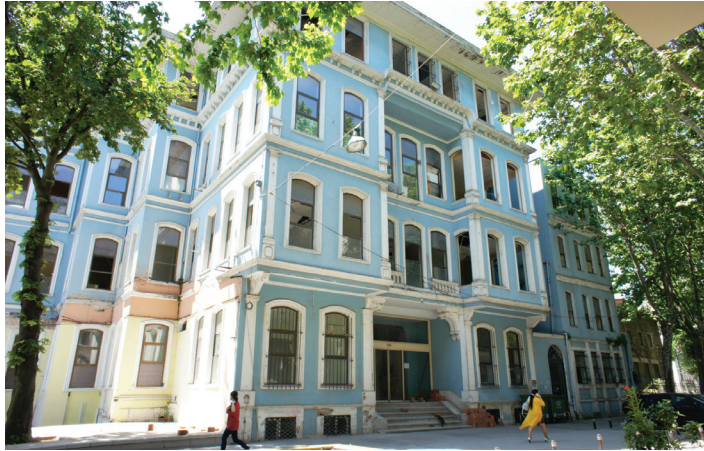
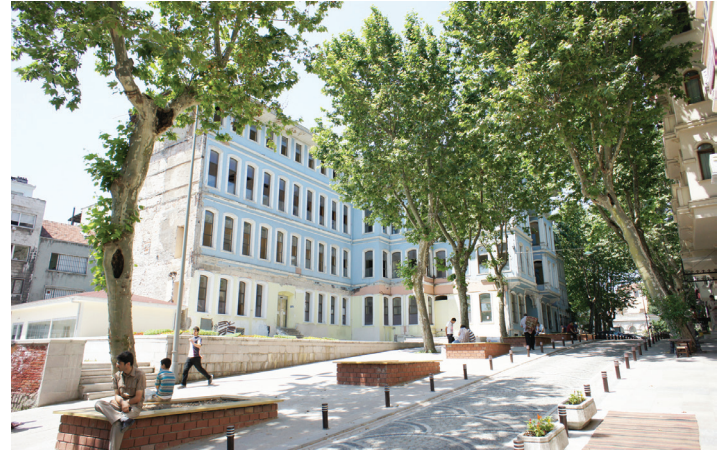
Yapılan son incelemede bodrum katta yer alan iki moloz taş duvarın kalınlıklarının 2010 yılı kurul onaylı rölöve projesine göre daha geniş olduğu tespit edilmiş ve projede bu doğrultuda çizilmiştir. Bu duvarlar çizimde tarama ve yazı ile ifade edilmiştir. Ayrıca yerinde yapılan incelemede onaylı rölöveden farklı olduğu tespit edilen bodrum katına ait çizimler, revize edilerek kurul onayına sunulmuştur. Kabul edilen yeni durum doğrultusunda yapı bodrum katı, restitüsyon ve restorasyon projelerinde onaylanan duruma uygun halde çizilmiştir.

Upon the latest review, it was determined that the thickness of two rubble walls in the basement floor were wider according to the relief project of 2010, as approved by the council, and the project was

drawn accordingly. These walls were expressed as shading and letters in the drawing. Additionally, during the inspection made in place, the drawings of the basement floor, which were determined to be different from the approved relief, were revised and submitted for the approval of the council. According to the new situation, as accepted, the building's basement floor was drawn in compliance with the condition approved in the restitution and restoration projects.

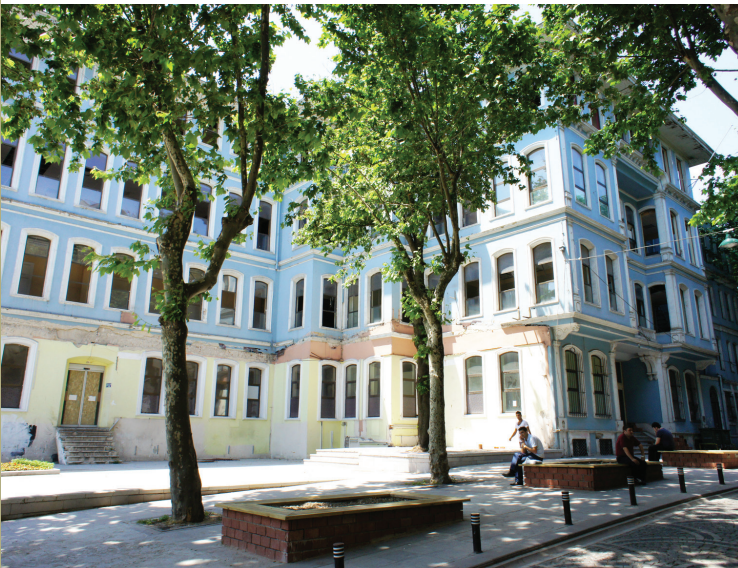
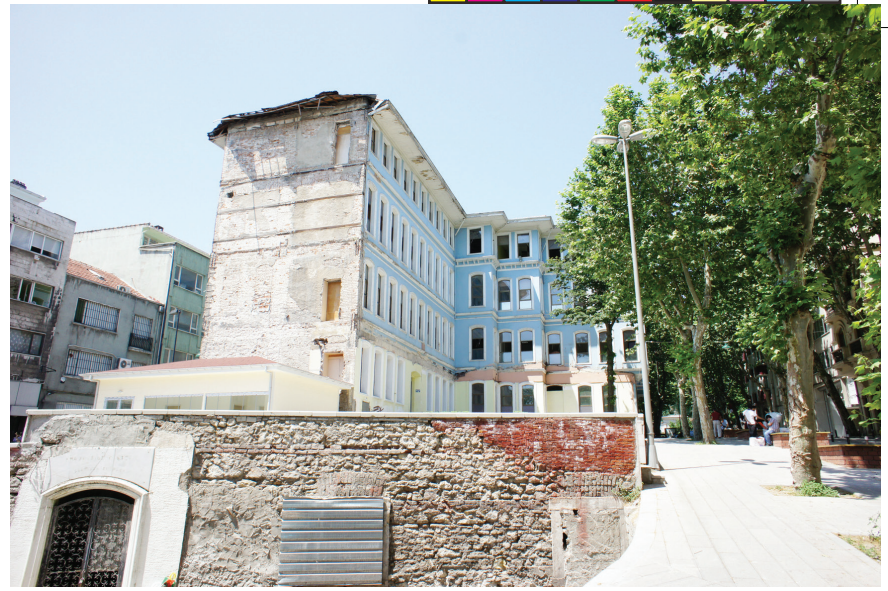
Cephelerde ki pencere ve kapı açıklıkları restirüsyon önerisindeki haliyle korunmuş, güney cephesi mevcut duvarlardan elde edilen izler doğrultusunda çizilmiştir. Kat silmeleri ve saçaklar mevcut yapıda bulunduğu haliyle korunmuştur. Yapının iç kapıları tipolojik ahşap kapılar ile değiştirilmiştir. Kuzey yönündeki gösteri merkezine yapı bütünlüğü gözetilerek kat silmeleri eklenmiştir. Taşıyıcı sistem çözümü İTÜ İnş. Müh. Fakültesi öğretim görevlisi Prof. Dr. Metin AYDOĞAN gözetiminde gerçekleştirilmiştir (Bknz. İnşaat Mühendisliği Raporu). En geniş aralığın 510cm olduğu yapıda, döşeme taşıyıcısı olarak 8/22 kesitli ahşap kirişler seçilmiş, bu kirişlerin üstü ve altı ahşap ile kaplanarak, mümkün olan en hafif ve güvenli taşıyıcı sistem oluşturulmuştur. Üç kollu merdivenin de bulunduğu orta salon için her katta 12/24 kesitli ana ahşap kirişler eklenmiş ve diğer kirişler bu ana taşıyıcıların üstüne oturtulmuştur. Plan çizimlerinde ahşap kirişlerin geçtiği yerler işaretlenmiştir. ◀

The gaps of windows and doors on the fronts were maintained as in the suggestion of restitution, and the southern front was drawn in accordance with the traces obtained from the existing walls. Floor moldings and canopies were remained as they were in the existing building. The interior doors of the building were replaced by typological wooden doors. Floor moldings were added to the show center on the north, considering the integrity of building. The load-bearing system solution was carried out under supervision of Prof. Dr. Metin AYDOĞAN, who is an instructor in the Faculty of Civil Engineering, ITU (see: Civil Engineering Report). Wooden beams with a section of 8/22 were selected as the floor retainer for the building, with the widest spacing of 510 cm, and these beams were covered by wood on the bottom and up, in order to create the most lightweight and safest bearing system possible. For the middle hall, which also includes the three-armed staircase, main wooden beams with a section of 12/24 were added on each floor, and other beams were placed on these main bearers. In plan drawings, the locations where the wooden beams pass through were marked. ◀
